1495 Bonhill Rd., Unit #12
Mississauga, ON L5T 1M2
Phone (905) 696-9391, Fax (905) 696-9395

Re: ULF Toilet Performance Monitoring Program

Veritec Consulting Inc. is pleased to provide the following report outlining the results of Durham's ULF Toilet Performance Monitoring Program.

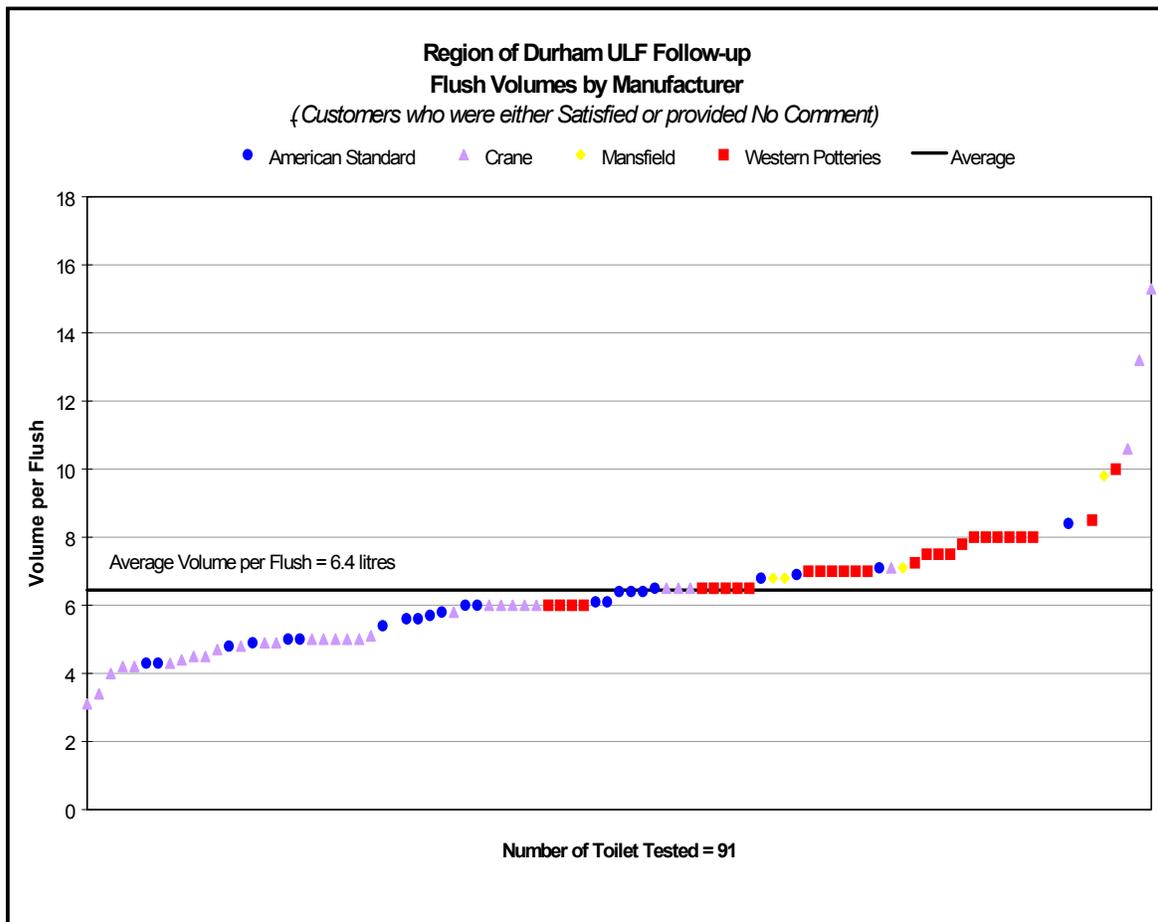
Figure 1 - Satisfied/No Comment Groups vs. Toilet Flush Volume

The average flush volume of the *Satisfied/No Comment* group was found to be equal to 6.4 litres; 46% of these toilets flushed with more than 6.5 litres.

In this group 11 of the 23 American Standard toilets and 20 of the 32 Crane toilets flushed below 6 litres, while 24 of the 28 Western Pottery toilets and all 4 Mansfield toilets tested flushed with greater than 6 litres.

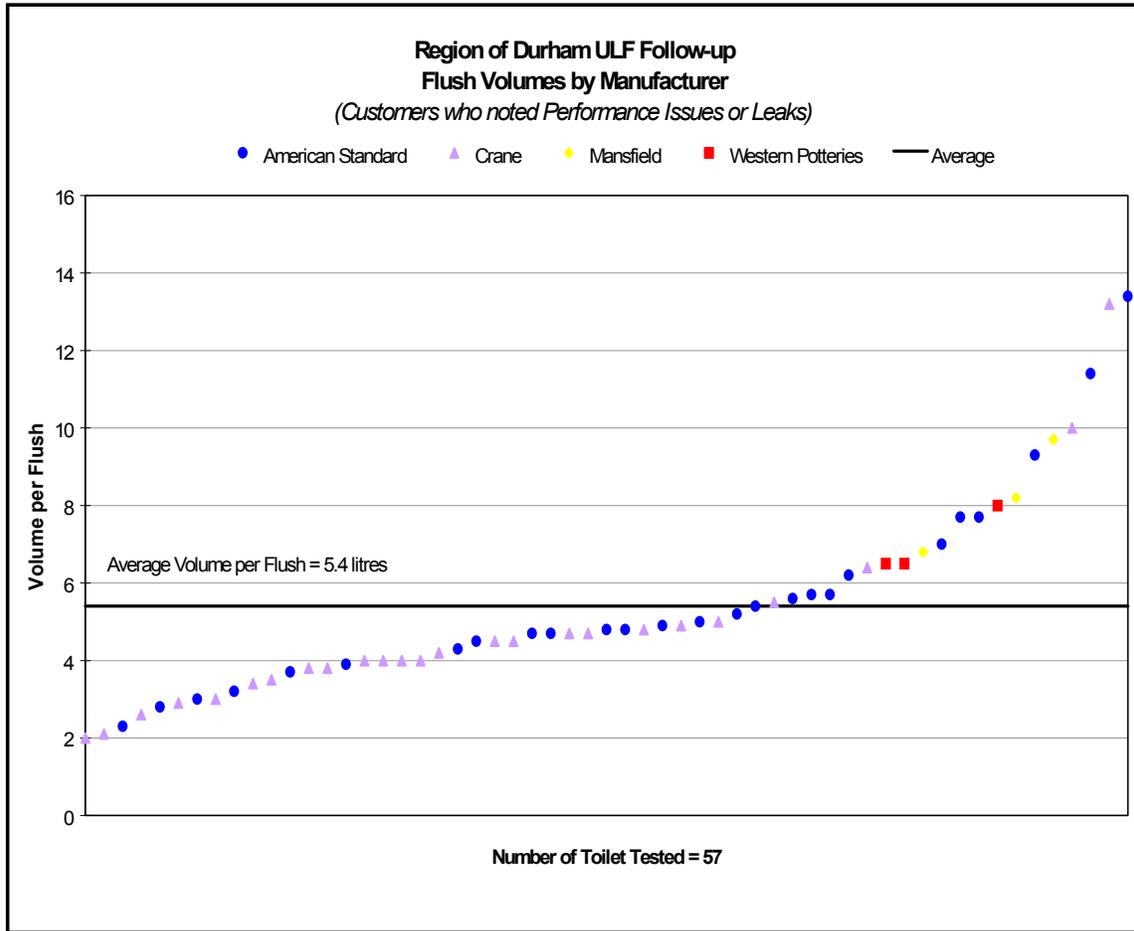
Figure 2 - Performance Issues/Leaks Groups vs. Toilet Flush Volume

The most common “performance-related issues” identified included clogging, double flushing, and the need to hold the handle down during flushing. Figure 2 illustrates the measured flush volumes of this group of toilets.

In this group 19 of the 26 American Standard toilets and 22 of the 25 Crane toilets flushed below 6 litres, while all 3 Western Pottery toilets and all 3 Mansfield toilets tested flushed with greater than 6 litres. The average volume per flush recorded in this group equals 5.4 litres; 72 % of these toilets flushed with less than 6 litres and approximately one third of the toilets “flushed” with less than 4 litres.

The toilets in this second group do not appear to be flushing properly at these low flush volumes. Double-flushing and holding the handle down are commonplace based on the participant comments. Note that ‘holding the handle down’ can result in discharging the entire tank volume during a flush – approximately 13 litres of water. Therefore, it appears that the flush volumes being measured in participant homes (i.e., the flush volumes resulting from depressing and releasing the handle) may differ from the actual flush volumes being practiced by the participants.

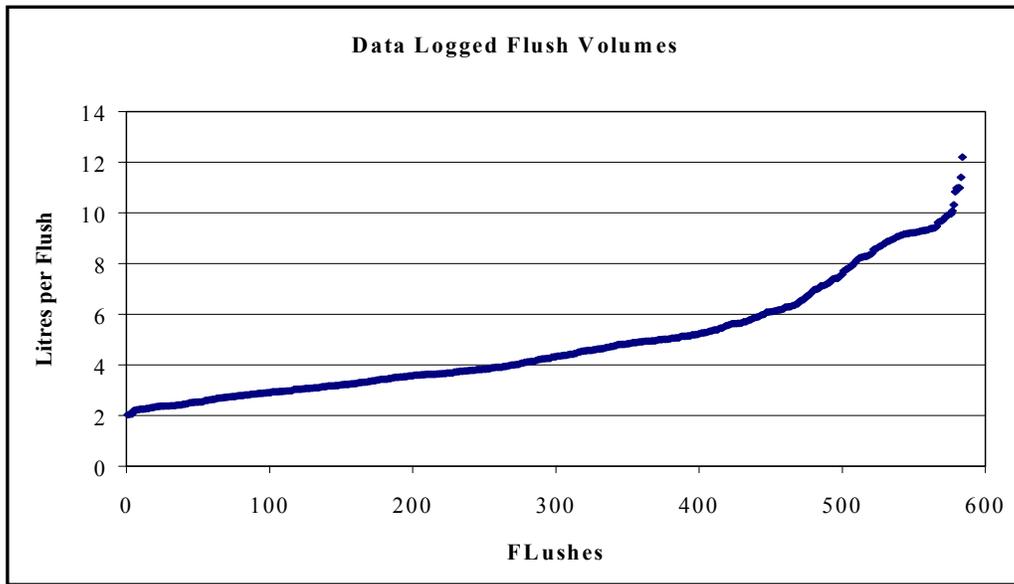
Figure 3: Range of Recorded Flush Volumes

A total of 584 toilet flushes were identified in the data analysis⁷ with a range of flushes of between 2.6 and 13.5 litres – a significant range of flush volumes for 6-litre toilets. The average of the data logged flush volumes is 4.8 litres. Figure 3 illustrates the variation in flush volumes recorded with the data loggers.

The range of flush volumes was determined by whether or not the handle was held down during the flush and, if so, to how long it was held down. As can be seen in Figure 3, the recorded flush volumes are relatively evenly distributed between about 2.6 litres and 10 litres, indicating that participants may depress the handle for different durations depending upon how much water they feel is required to clear the bowl.

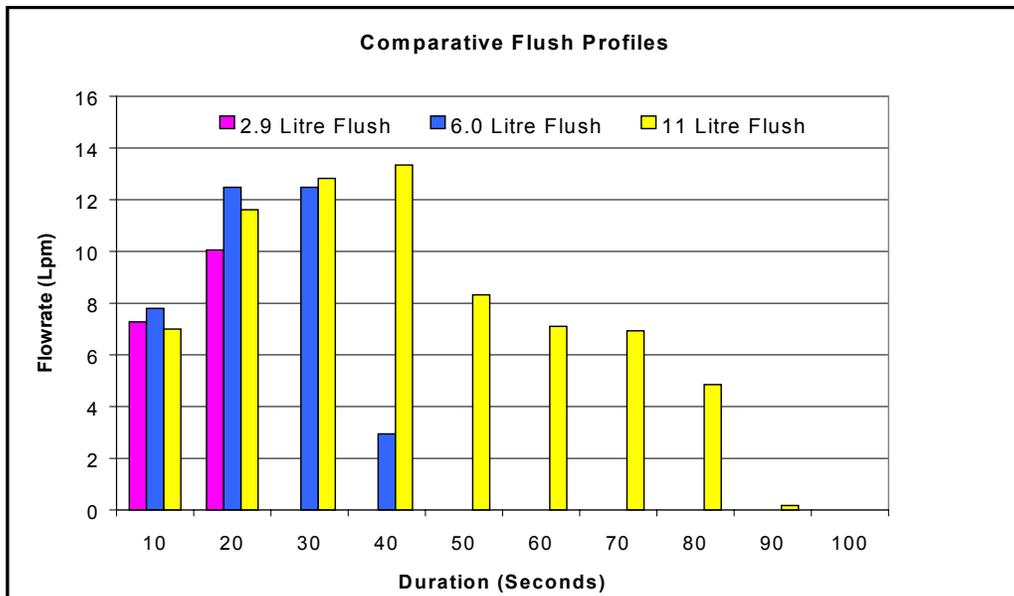
Figure 4: One Toilet and Three Flush Volumes

This ‘flush volume variation’ is wholly at the participant’s discretion and is illustrated further in Figure 4 below. This figure shows three very different flush profiles (and volumes) for a single toilet in one of the participating homes.

- The first flush volume of 2.9 litres in Figure 4 suggests the flapper closes almost instantly – as was the case when the toilet was originally tested and the measured flush volume equaled 2.8 litres.
- The second flush of 6 litres represents what would be considered a “proper” flush profile.
- And the third illustrates the additional consumption when the handle is held down – likely until the bowl is cleared.
