# ICING ON THE CAKE WHERE INFRASTRUCTURE MEETS SUSTAINABLE LANDSCAPES

### LB CCC CAMPUS OVERVIEW

## IRRIGATION MASTER PLAN - CONNECTING THE WATER

### ALVORD USD CAMPUS OVERVIEW

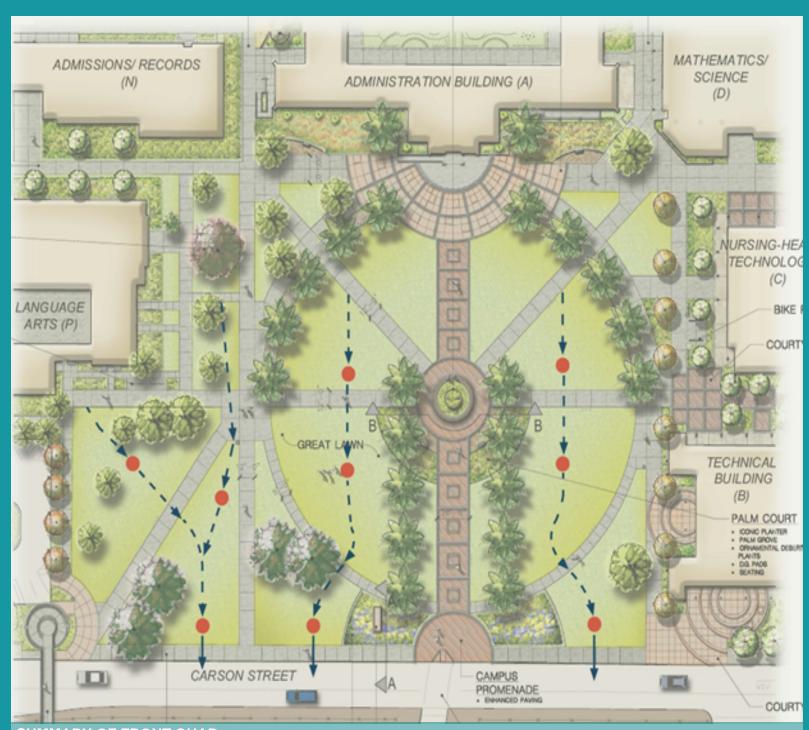
### LBCC FRONT QUAD SOLUTION

The front quad was flat and had no drainage - any rain equaled flooding. There were extensive utility conflicts, plus no documentation for some of the underground infrastructure. Space for drainage retention was limited to a few spots. The school did not want runoff from the quad going into an already overloaded city stormwater system. The solution was a series of concrete dry wells (red dots) to retain water until it could infiltrate into the ground or overflow into city system. The wells have a 4' interior diameter with 4"-thick precast concrete liners.

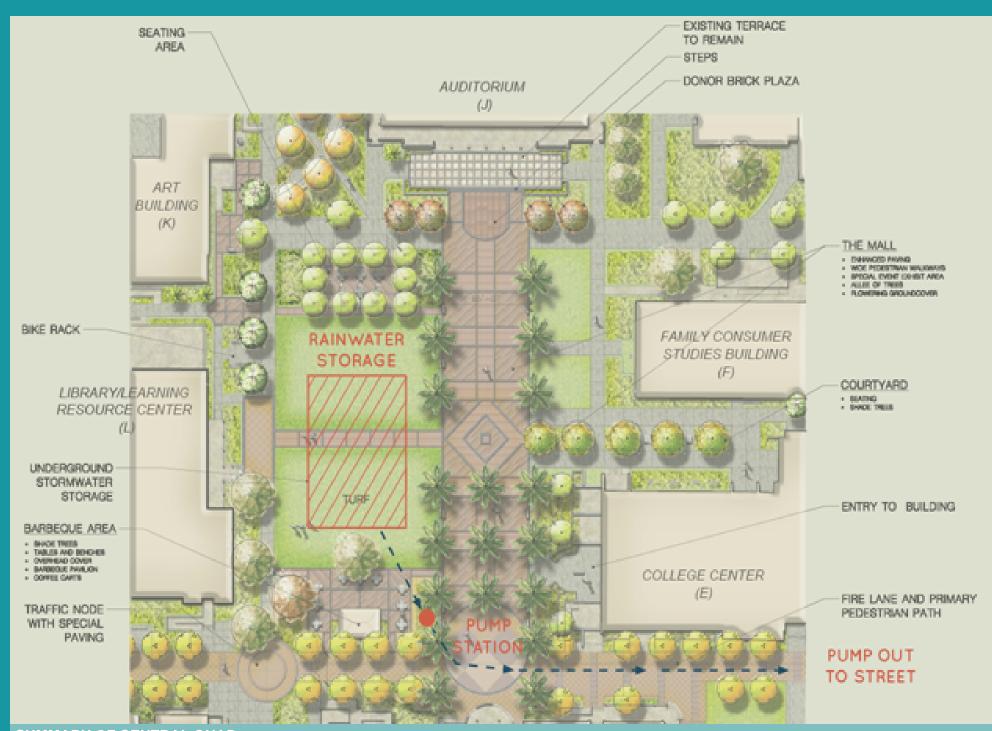
The central quad had a flat terrain with an undersized drainage system. The existing large turf areas (balanced by new drought-tolerant plantings) allow for underground water capture and retention of runoff. A horizontal system of 8' diameter galvanized storage tubes were implemented as the best solution for water capture and retention option. This stored runoff is released slowly to a pump station via concrete drainage tubes three feet in diameter, augured to a depth of 13 feet. The pump station regulates the release of this runoff to the street, where it flows into the city's stormwater system.

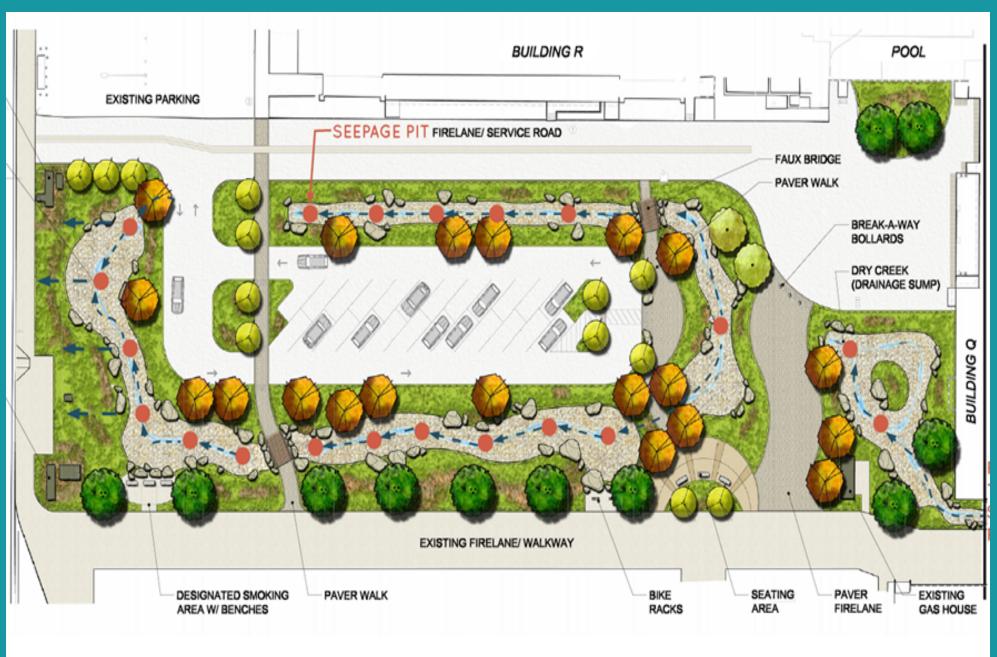
# LEW DAVIS PARKING SOLUTION

The existing parking lot site was flat, had poor drainage and received runoff from adjacent buildings and street which inevitably caused flooding. Additionally, the site had a high water table and potential archaeological impacts if excavation exceeded 13 feet. The proposed design employed concrete drainage tubes three feet in diameter, augured to a depth of 13 feet. The tubes collect the runoff from the street and adjacent buildings during storms and retain it in the managed drainage swale until the water can infiltrate first into the tubes and then through the clay soil and into the water table.

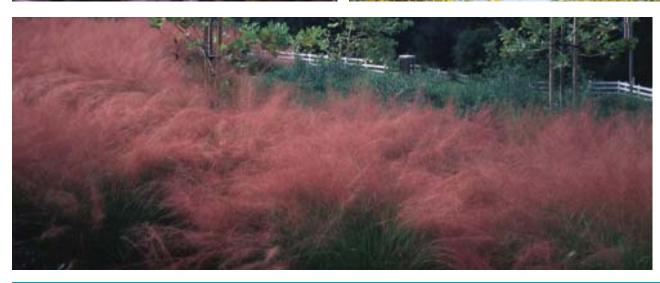
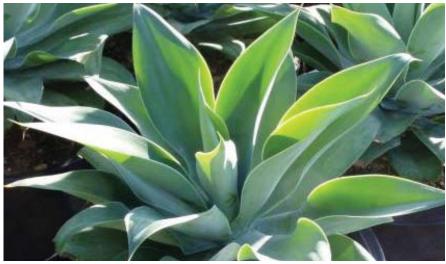
WATER MANAGEMENT ASSESSMENT LANDSCAPE, IRRIGATION, DRAINAGE

#	LA	IR DF	OBSERVATION OF EXISTING CONDITIONS	PROPOSED SOLUTION
1	x	x x	patio. Because of inadequate drainage capabilities the rain creates ponding over existing sidewalk connection.	Redesign Courtyard from large turf area to Rain Garden with diverse plant materials which could potentially improve stormwater infiltration and drainage and provide a natural education feature for students / teachers - team discussed potential solution of developing rain garden within north planting area (low point) to capture stormwater runoff and allow for water to be slowly released into storm drain system, infiltrated, and celebrated. There is Opportunity for rain garden to become educational element for students as well. Team also discussed rerouting of walk to covered plaza and removal of portion of existing walk to enlarge proposed rain garden area. Irrigation system retrofit would be required for any redesigned landscape areas. For this proposed solution, LCI recommends further investigation into the site grading, stormwater management, landscape design, and irrigation. All grading / drainage solutions to be further investigated by Civil Engineer.

2	х	х	Interior Courtyards – landscape of the interior courtyards consists predominantly of turf. Turf is extremely water intensive and state regulations are mandating reduction of water use. Most of the existing trees were observed to be in adequate condition and providing large amounts of shade.	Reinvigorate Courtyard from large water intensive turf areas to water-wise aesthetic landscape feature - redesign by strategic replacement of some turf areas with drought tolerant plants and/or inert materials (see image palettes). Redesign of courtyards could tie into design of proposed rain garden. Irrigation system retrofit would be required for any redesigned landscape areas.
3	х	х	Black Top – there is an 8-10' wide border of exposed soil (no turf / planting) at perimeter of blacktop area. Client expressed issues (slippage) with transition from blacktop to athletic field because of dirt / gravel build up. There is opportunity for providing landscaped edge to fill in bare areas.	Provide planted transition at perimeter of black top area - install low growing drought tolerant plant material and retrofit irrigation system. Mulch, artificial turf, or hardscape elements could be provided within proposed planting area to allow access points between adjacent sports fields and black top area. Irrigation system retrofit would be required for any redesigned landscape areas.

4		х	North Courtyard Drainage – drainage from this area is not reaching the under sidewalk drain.	Regrade turf area and clean drain out - regrading area would direct water to the drain.  All grading / drainage solutions to be further investigated by Civil Engineer.
5	х	х	Exposed Soil at Pavement Edges – there are conditions of 2-3' wide border of exposed soil (no turf / planting) at edge of pavement within interior courtyards. Potential for slipping hazard from dirt / gravel build-up and visually unappealing	Provide planted transition at exposed areas along perimeter of concrete - install low growing drought tolerant plant material and retrofit irrigation system.  Renovation could tie into development of courtyards and proposed rain garden
6	х	х	School Entry – landscape of the main entry / parking area (Fillmore / Indiana) consists predominantly of turf. Turf is extremely water intensive and state regulations are mandating reduction of water use. Additionally there are no shade trees in parking areas.	Reinvigorate Main Entry from large water intensive turf areas to water-wise aesthetic landscape feature for students, teachers, visitors, and neighborhood redesign by strategic replacement of some turf areas with drought tolerant plants and/or inert materials (see image palettes). Additionally install trees in existing parking islands to give shade for parked cars. Irrigation system retrofit would be required for any redesigned landscape areas.

7	х	х	Existing Tree in South Courtyard – tree is in poor condition and visually unappealing	Reinvigorate South Courtyard with new specimen tree(s) - remove and replace existing tree with new tree or multiple trees. The space is large enough that multiple fruit trees could be installed and utilized as educational opportunity for students and teachers to grow their own healthy food. Irrigation system retrofit would be required for any redesigned landscape areas.
8	х	х	West Perimeter Trash Enclosure – existing views at west perimeter along Fillmore Street to trash enclosure are visually unappealing from surrounding neighborhood.	Provide soft green edge and screen unappealing views to trash enclosure - install tall vertical drought tolerant plant materials in front of trash enclosure fencing. Irrigation system retrofit would be required for any redesigned landscape areas.
9	х	х	Existing Transformer – existing transformer in west courtyard adjacent to classrooms and is accessible to students and visually unappealing	Provide soft green barrier and screen unappealing views to transformer - install medium height shrubs around 3 sides of transformer to provide barrier between student use and screen primary views. Access shall still be provided. Irrigation system retrofit would be required for any redesigned landscape areas.

10	х	x	Existing Pump Station – existing irrigation pump is adjacent to playground. In discussion with maintenance staff, the pump is antiquated and has not been in use for a long time. The pump is in a fenced enclosure but could create potential liability for kids playing adjacent to it. Additionally the pump and fenced enclosure are visually unappealing.	Option 1 - Provide soft green barrier between playground and screen unappealing views to pump - install medium height shrubs around enclosure on playground side to provide barrier between student use and screen primary views. Access can be provided from parking area. Irrigation system retrofit would be required for any redesigned landscape areas.  Option 2 - Remove pump (and associated equipment) - remove pump and reconnect pipes underground with the mainline. This option requires further investigation by civil engineer and LCI
11		х	Existing Irrigation System – existing irrigation system has two points of connection and neither connection has a master valve or flow sensor installed. This may create a situation where irrigation mainline is constantly under pressure and will cause stress	Install flow sensors and master valves - It is LCI's opinion that this can be accomplished with minimal disturbance to the existing landscape with current controller technology. This would help protect mainline and monitoring.

12		х	Existing Irrigation Controller – the existing Hunter ACC and ICC controller are not currently connected to a centralized system or a web server receiving local weather data for self-adjusting. These controllers are not considered smart controllers.	Replace existing controllers - install new controllers that are capable of communicating with each other to share flow from the same mainline and monitor usage based on mainline capacity. It is LCl's opinion that replacing existing controllers can be done without major construction work to the existing infrastructure. This would help protect mainline and monitoring.
13		х	<b>Existing Backflow Preventer</b> – there are (2) existing backflow preventers. One backflow services only the athletic fields while the landscape outside of the athletic fields (classrooms, parking, etc) is serviced by an outdated (not per code) backflow. Current code requires a backflow preventer for irrigation systems to be code compliant as there is potential for cross contamination for system back into water connection	Retrofit existing irrigation system - connect system that has outdated backflow preventer to existing backflow preventer. This is a serious condition and should be undertaken immediately.

14	х	x	Existing Garden Areas – there are existing wood planters which contain dying plant material and the (2) garden areas in fenced enclosures (west perimeter) are need of refresh. It is not known whether the gardens are actively being used by the students	Provide engaging new garden areas for student / teacher hands on educational experience - work with school to redesign and replant garden areas as opportunity to engage students and teachers with the outdoors and provide educational experience. Additionally new materials, colors, site furniture, and outdoor "work stations" could be implemented to further enhance the experience for students and faculty. Experience could be collaborative with LCI working with and receiving input from students and teachers on the garden use and design.
15	х	x	Black Top Shade Trees – there are large shade trees on east side of school at black top with some small seating areas. Client expressed interest in providing more seating and taking advantage of shaded areas.	Activate space by providing additional seating / outdoor classroom opportunities around the large shade trees - the space is well shaded and large enough that with additional site furniture the space could potentially be used for outdoor teaching opportunities. Selected site furniture could be made from recycled materials providing additional educational experience for students and teachers. Seating would also provide space for parents to relax comfortably in the shade while watching their kids play on adjacent fields.

16		х	Blacktop – drainage is ponding at playground blacktop low point	Civil is not recommending any solution for the blacktop ponding unless the play area will be reconstructed  All grading / drainage solutions to be further investigated by Civil Engineer.

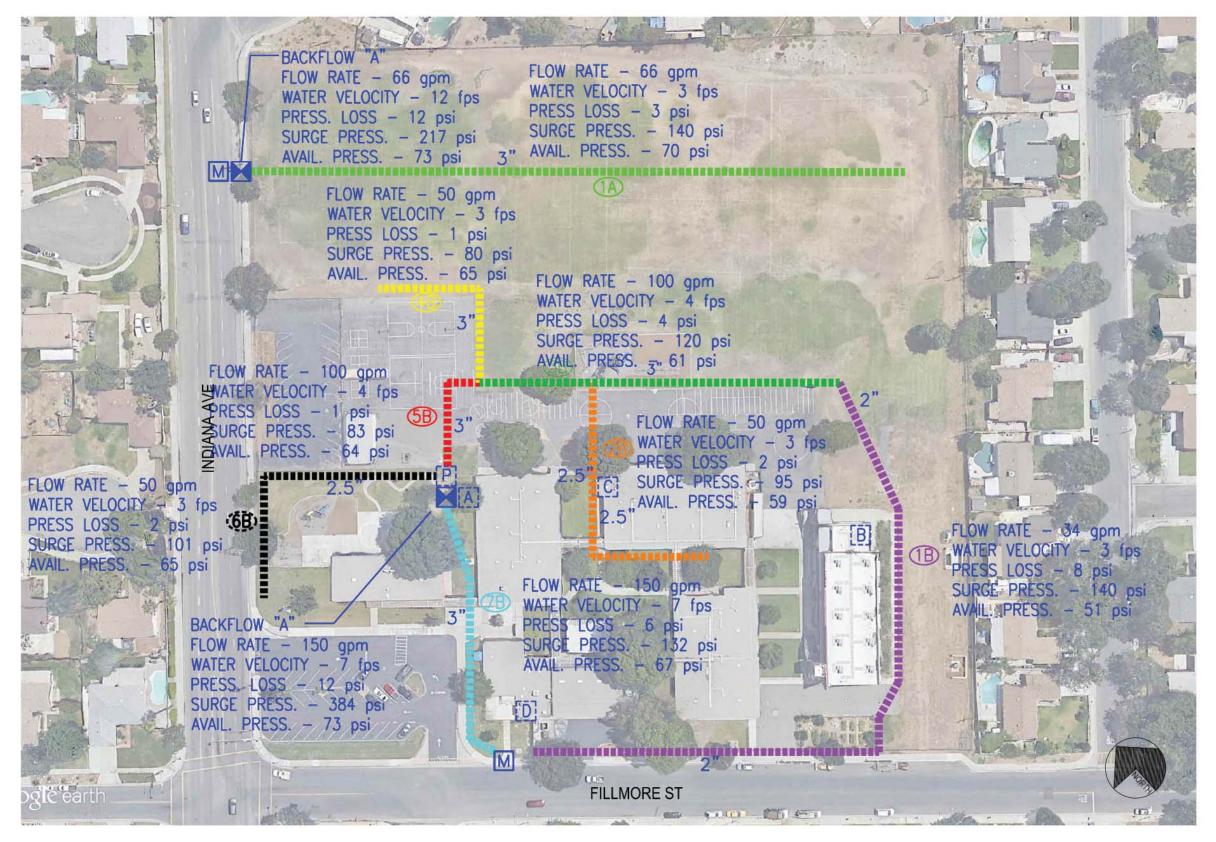
- M EXISTING WATER METER
- EXISTING BACKFLOW PREVENTER
- [A] EXISTING 7 STATION CONTROLLER
- (B) EXISTING 3 STATION CONTROLLER
- [C] EXISTING 18 STATION CONTROLLER
- [D] EXISTING 7 STATION CONTROLLER
- P EXISTING PUMP STATION
  - EXISTING IRRIGATION MAINLINE

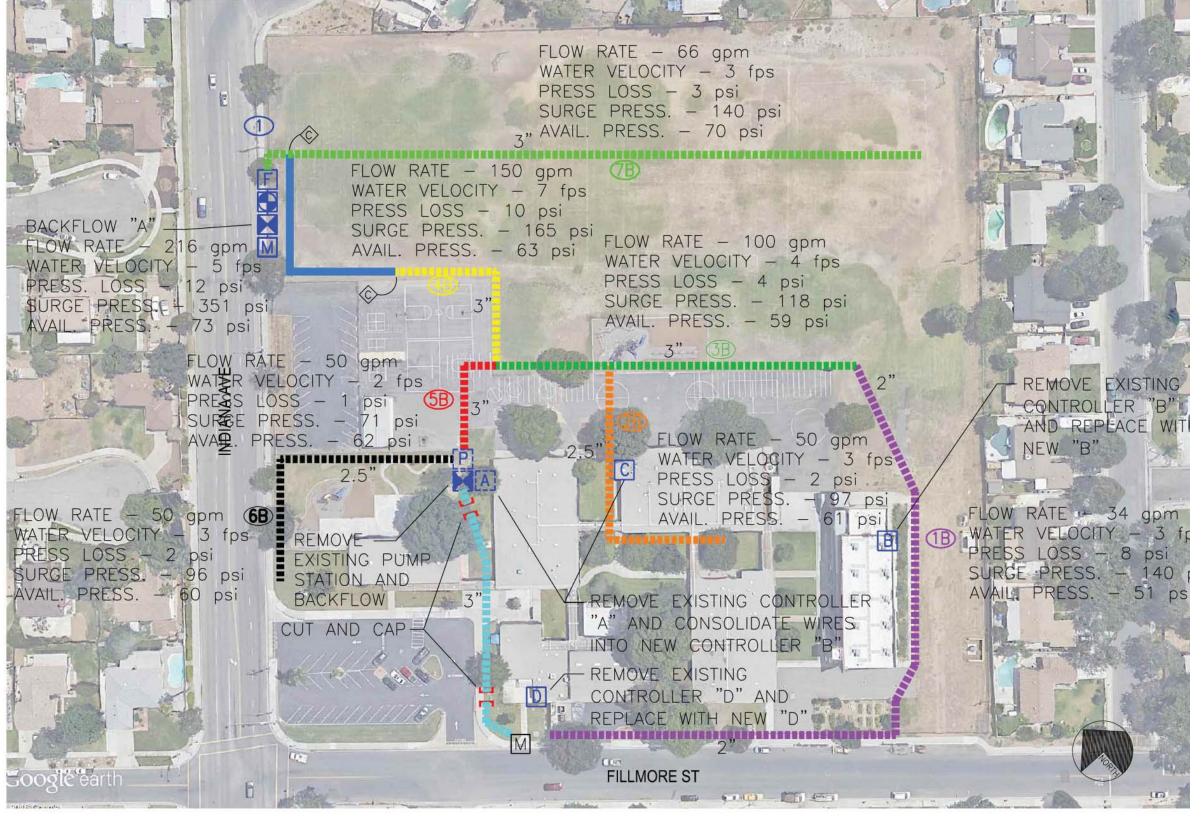
\*note - analysis is for stress on existing mainline system

- M PROPOSED WATER METER
- M EXISTING WATER METER
- PROPOSED BACKFLOW PREVENTER
- PROPOSED IRRIGATION MASTER VALVE
- F PROPOSED IRRIGATION FLOW SENSOR
- A PROPOSED X STATION CONTROLLER
- B PROPOSED X STATION CONTROLLER
- C PROPOSED X STATION CONTROLLER
- D PROPOSED X STATION CONTROLLER
- PROPOSED IRRIGATION MAINLINE
- EXISTING IRRIGATION MAINLINE
- ---- EXISTING IRRIGATION MAINLINE TO BE ABANDONED IN PLACE
- C CONNECTION
- CUT AND CAP PIPE
